In-bore Detonation of Non-standard Ammunition,
Testing a Russian T-55 Tank

Steven J. Reeves and Ralph Scutti

In-bore Detonation of Non-standard Ammunition

July 2010

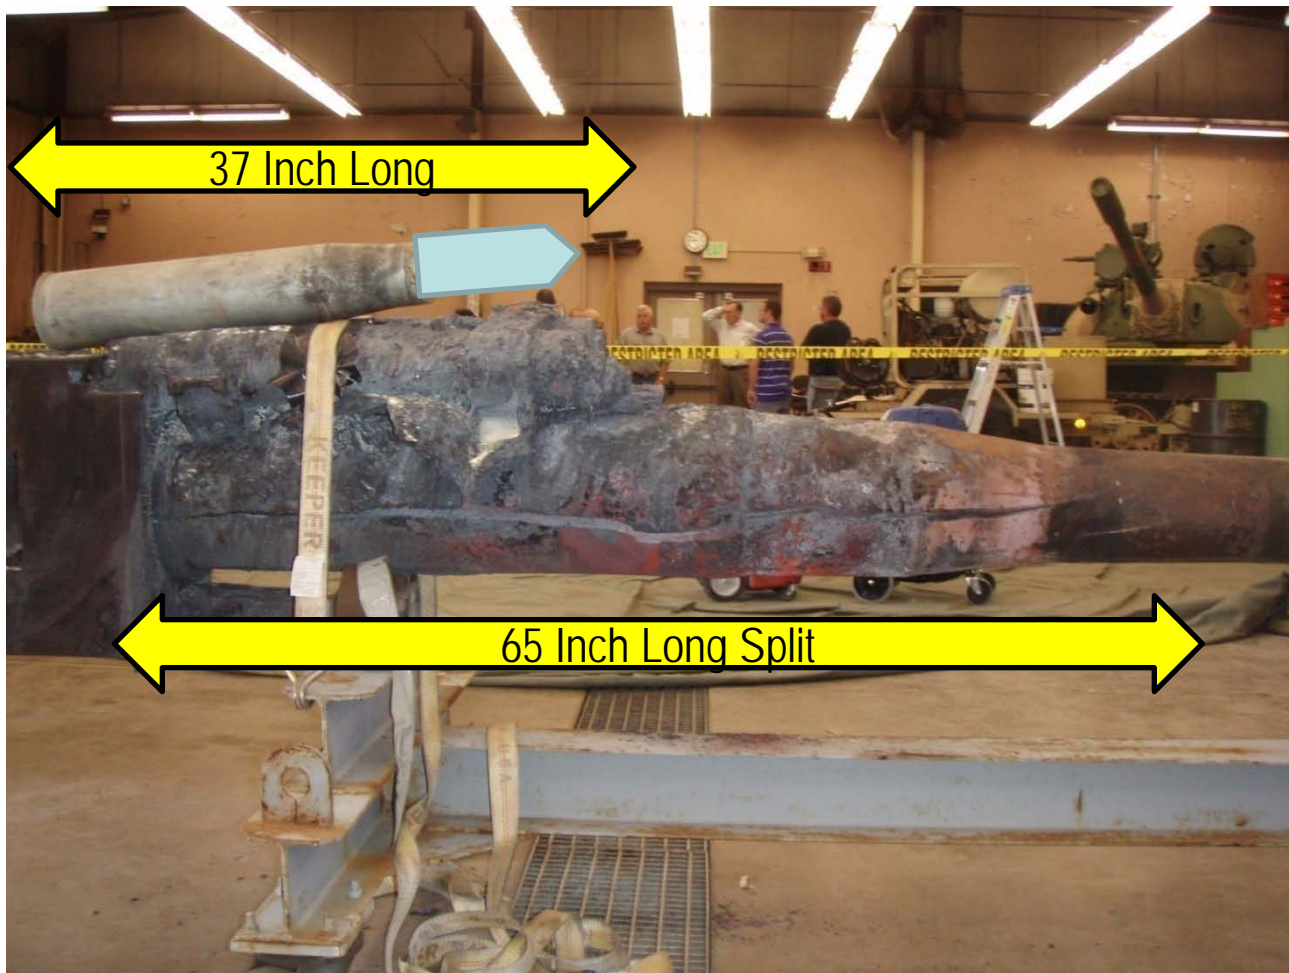
Post Incident

- Gun tube manufactured ~ 1974
- No inspection records prior to 1995
- Benet Labs post incident failure analysis
 - Gun Tube could safely fire HEAT round
 - Projectile detonated in gun tube
 - Projectile traveled ~ 16 inches prior to event
 - Projectile was near maximum acceleration at event
